TOWN OF NORTH JUDSON, INDIANA

## 205-207 LANE STREET STRUCTURAL INTEGRITY REPORT

DLZ Project No: 1761-4464-90

Inspected: May 19, 2017

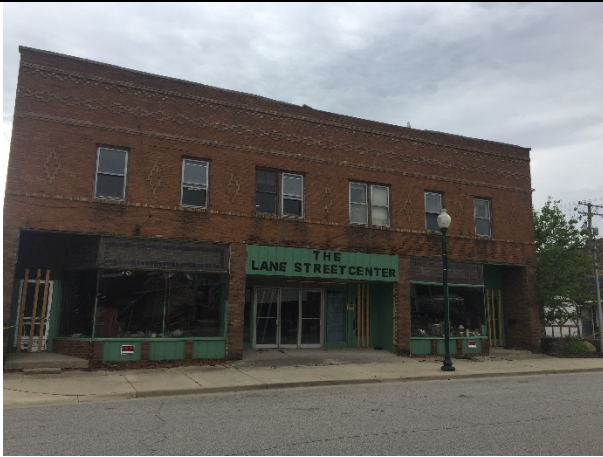
**Picture No. 1**

General overview of the west side.

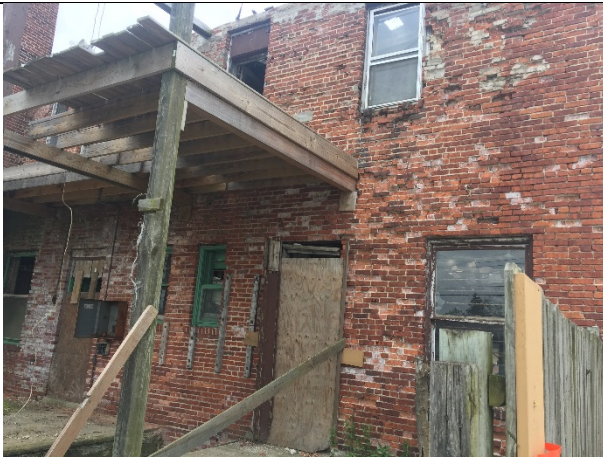
**Picture No. 2**

General overview of the east side of the building. Note failing brick

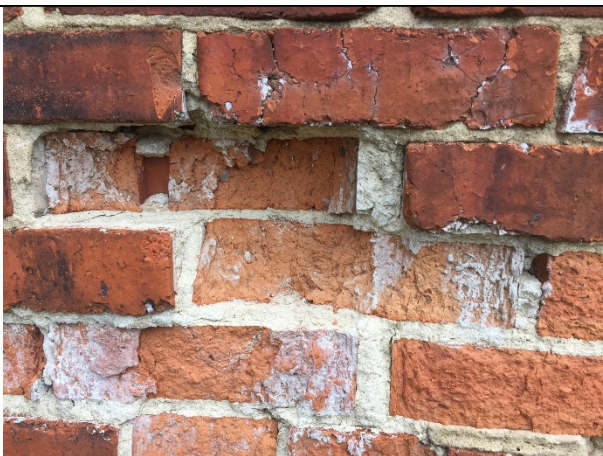
**Picture No. 3**

Typical condition of brick and mortar.

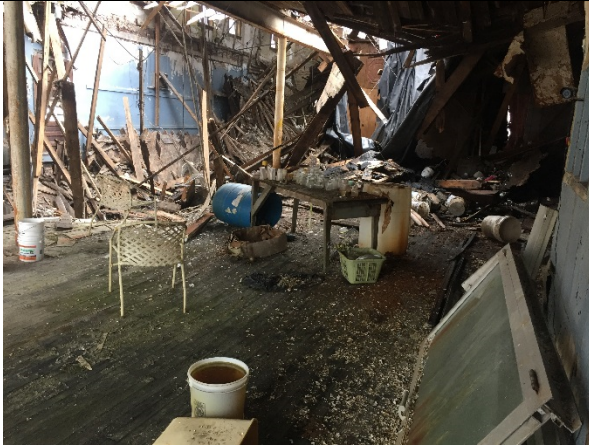
**Picture No. 4**

205 Lane Street floor failures. Note first floor is on the bottom and second floor is on top.

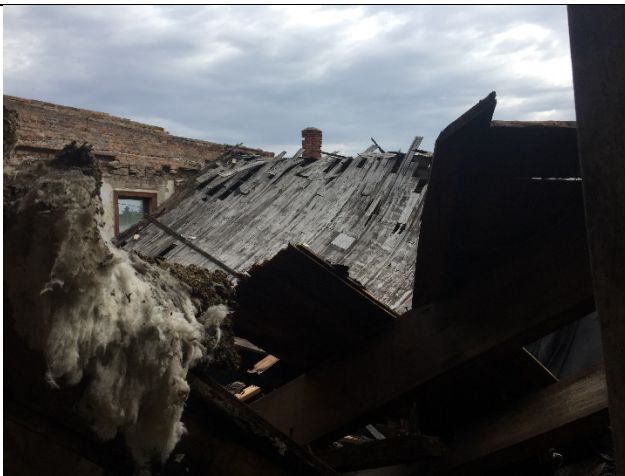
**Picture No. 5**

205 Lane Street roof collapse.

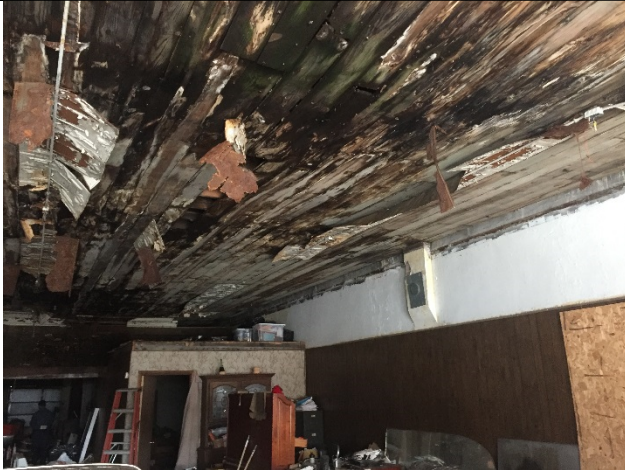
**Picture No. 6**

207 Lane Street second floor framing wet, rotting and sagging.

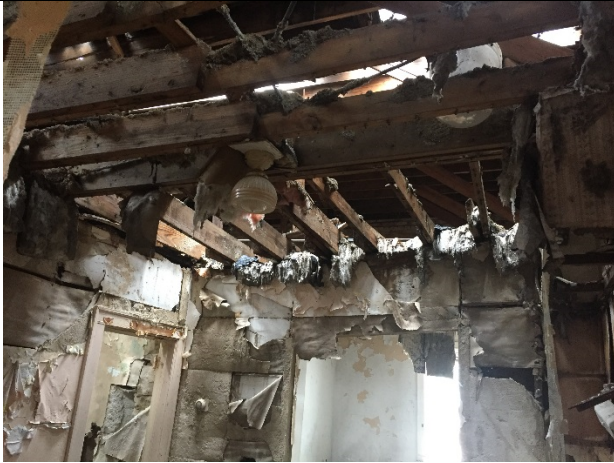
**Picture No. 7**

207 Lane Street roof framing failing and open to the sky.
